Working with Mother Nature - Not Against Her

SLOPE STABILIZATION

by Pat Dixon, Rob Walker and Dylan McCullick

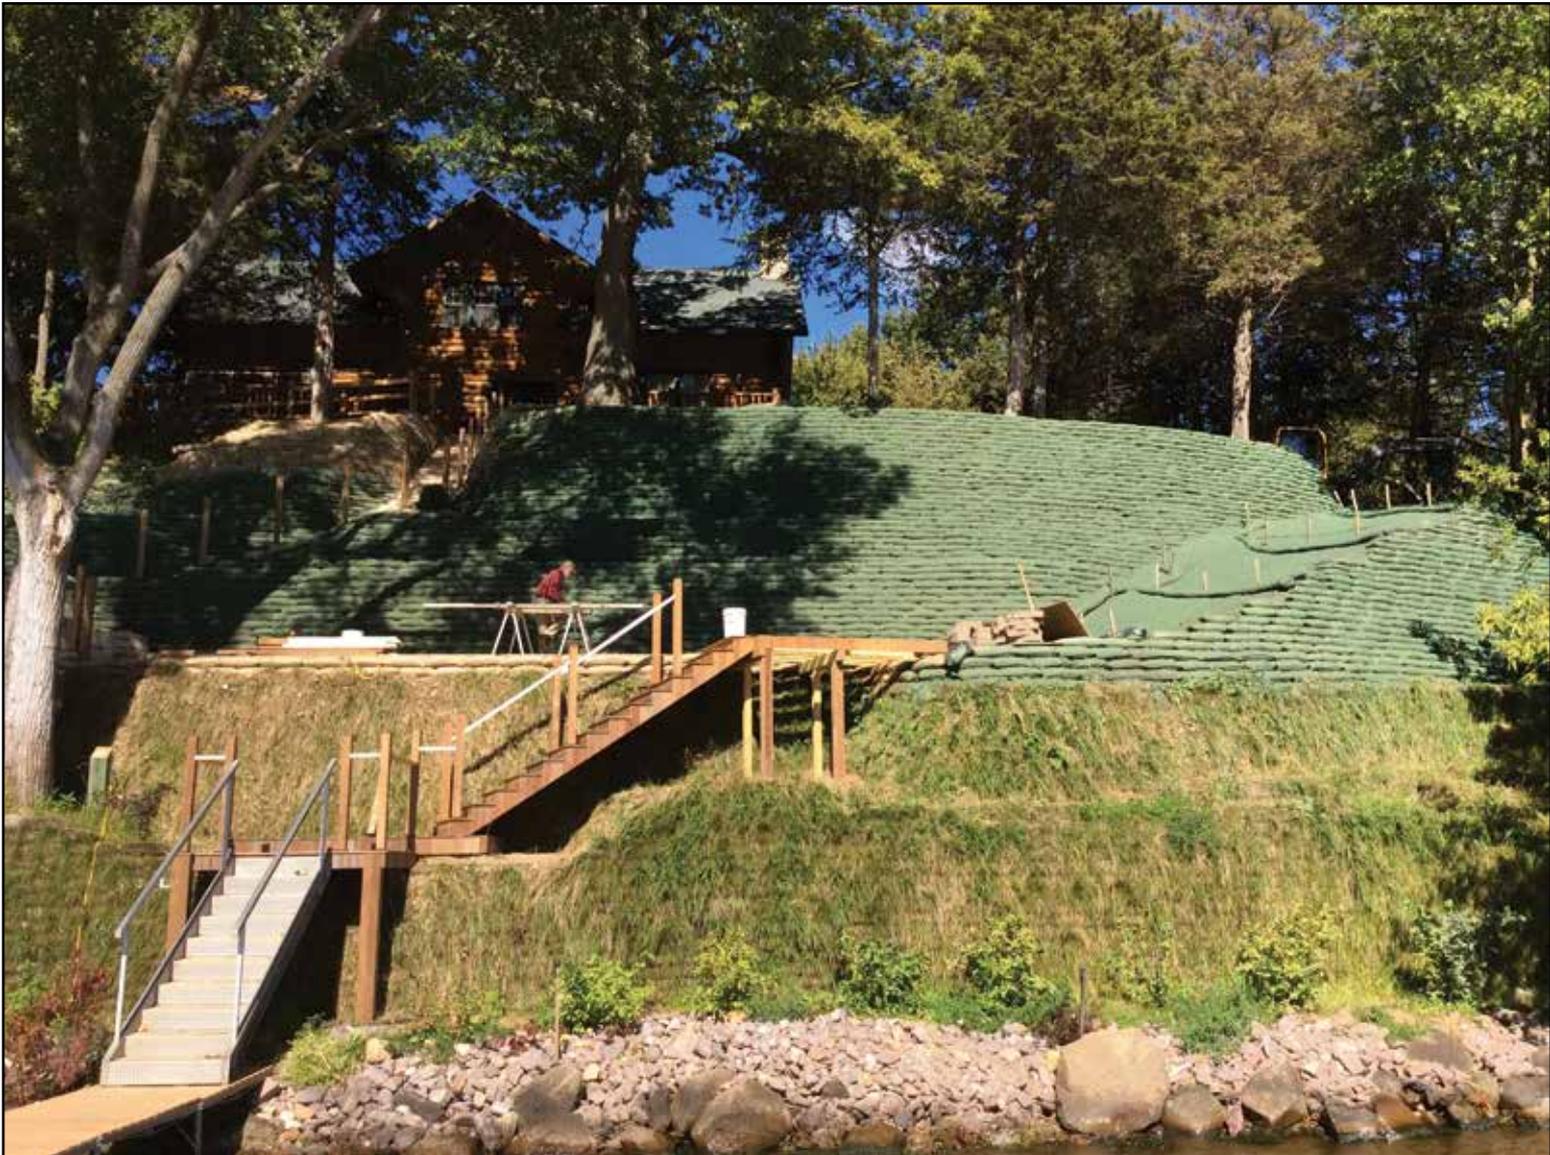
Completed Envirolok progress from the fall of 2015.

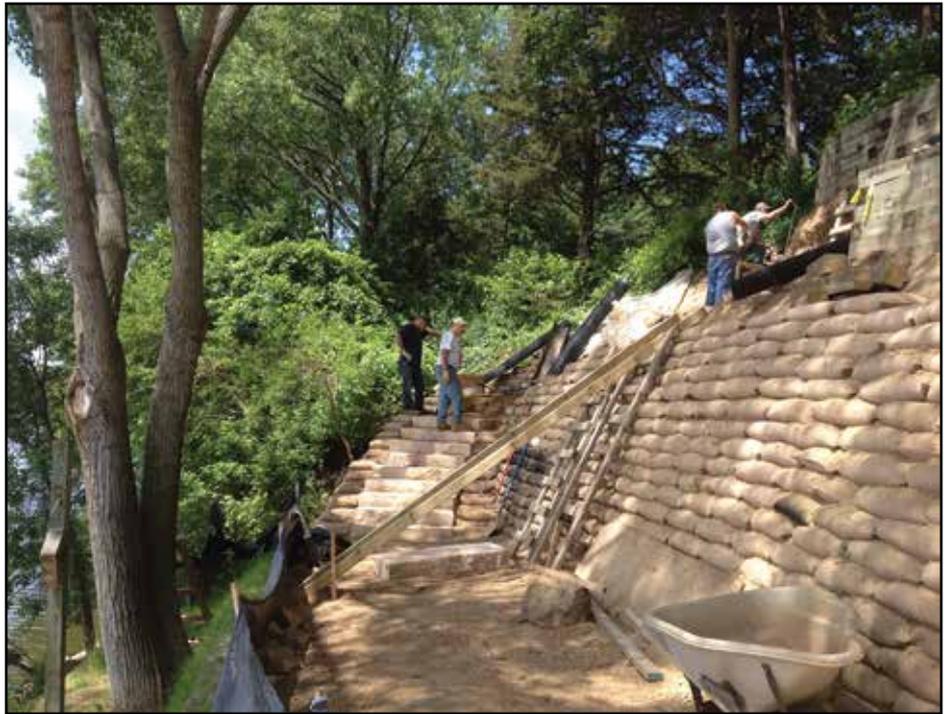
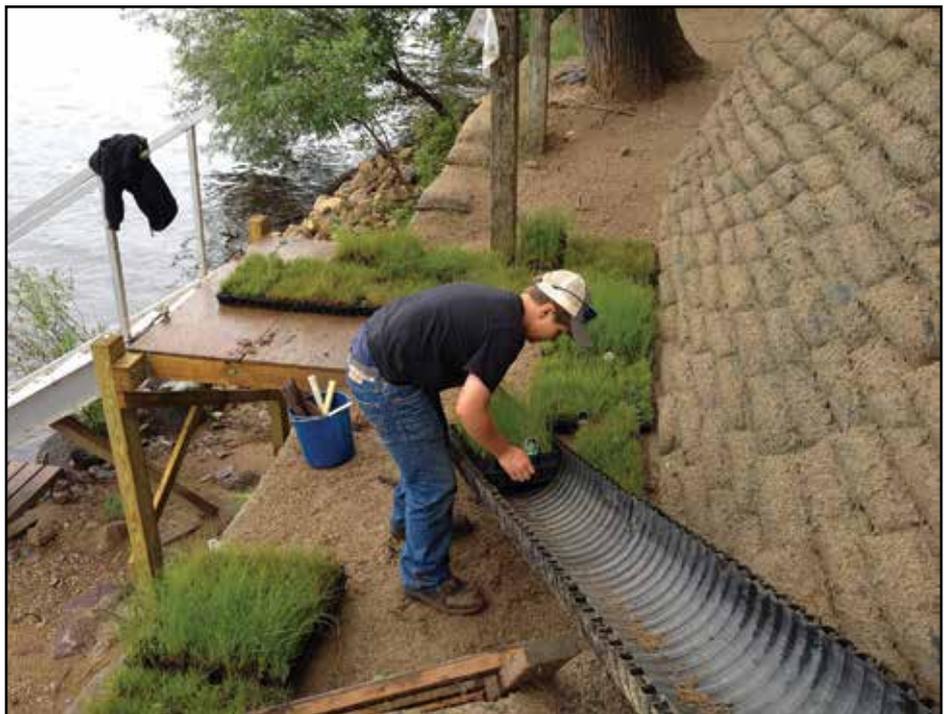
Above: During mid-summer of 2015, installation of steps and removal of timbers were taking place. Below: During early spring of 2014, tube system shown was used to transport native plugs for planting.

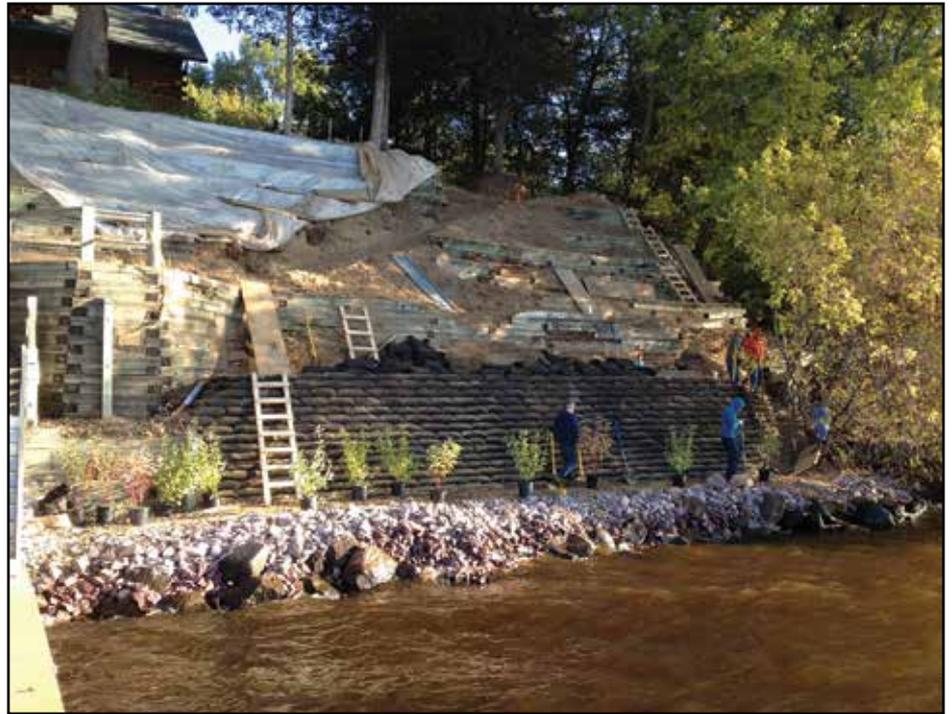
During the fall of 2014, native shrubs were being prepared for planting while soil bag installation was underway.

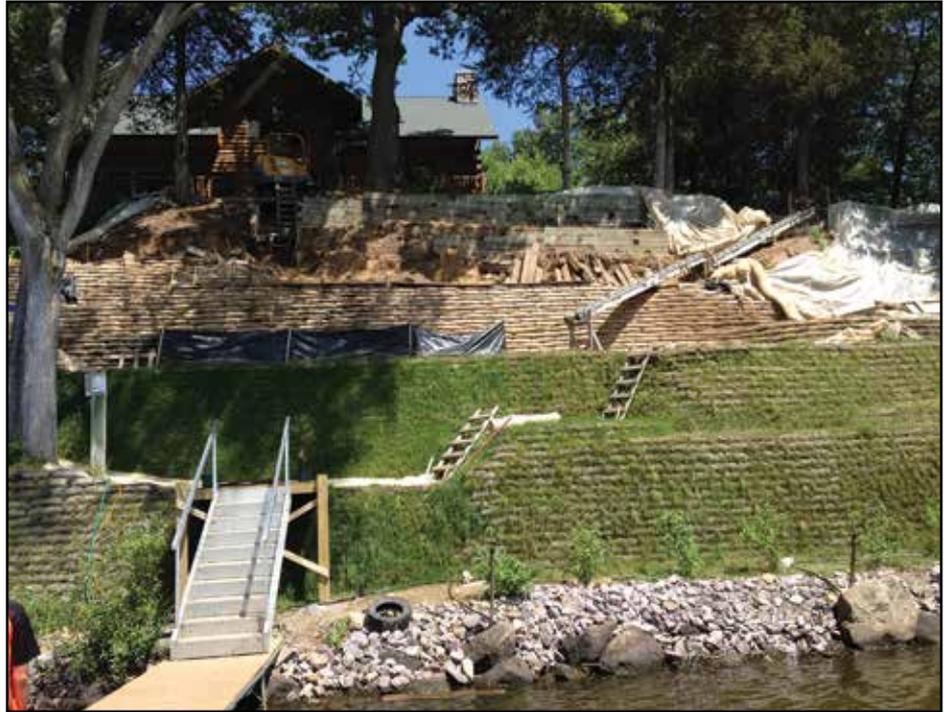
Different stages of the project show the following: vegetated slope on the bottom, constructed wall in the middle, and old existing wall being removed at the top.

Three 24" x 20' PVC conduits were bolted together and installed to transport material to the different levels, with a steel plate at the end to be used as a backstop. Once material was transported, installation of the bags started. Earth anchors, BMX polypropylene geogrid, and coated rebar were specified in the engineering plans for stabilization. The earth anchors were installed every 2' vertically and 6' horizon-

tally. The earth anchor process connects a 3/16" cable to an anchor that is driven 12' to 14' into the ground and connects the other side to rebar which is then placed on the bags. Geogrid was used every 2' lift, cut into 3' x 4' pieces and installed the entire length of the wall. Since this was such a large project, it was split into multiple sections. After the bags were all placed on the first section, 4,000 2" native plant plugs were installed and the section was hydroseeded, resulting in established plants the following spring. Since this section was finished in November of 2014, winter preparation was required. This involved 2-mil plastic sheets tented over the already seeded site creating a greenhouse effect. Twelve inch wood fiber wattles and silt fencing were installed at the top of the hill to alleviate the pressure from service run-off of melted snow and spring rain.

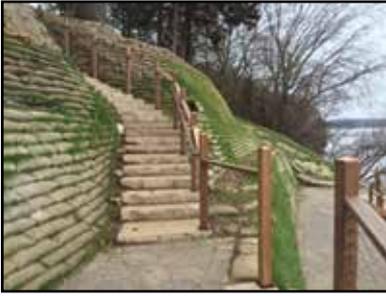
Stone steps and hand rail ascending the slope.

pier. To ascend the hill 8' to the next small paver level, composite stone stairs with geotextile fabric on the underside were installed. From this small level to the top of the hill, 38 stone stairs were put in. The stairs were a challenge because they had to be recessed like the old wood stairs. After 3 weeks of stairway construction, a handrail was installed to meet building codes. With all of the construction complete, a heavy native seed mix was hydroseeded onto the soil bags. Preparation for winter included installation of wood fiber sediment logs, Curlex net free rolled blankets, Recylex permanent BMPs, silt sox, straw blankets, and silt fence. A mild winter resulted in ex-

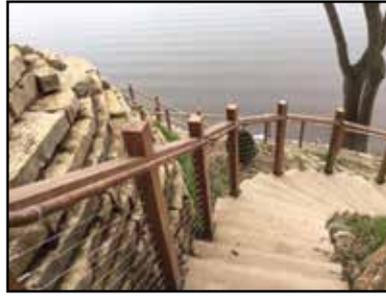
Stone steps and hand rail descending the slope.

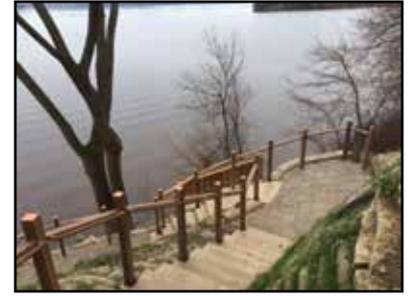
View of a paver patio amongst the beautiful stair system.

path was a must, not to create an erosion path down the stone stairs, which would have to have railings. The original drawing for the path proposed above ground stairs throughout. On the lower level, a 5.5' wide by 40' long paver walkway was created 8' up from the soil bag wall. This allowed access to an above ground set of stairs down to the
