Working with Mother Nature - Not Against Her

In late July of 2014, Dixon Shoreline Landscaping, Portage, Wisconsin, was contacted to evaluate the existing condition of a hillside at a private residential property located on Lake Wisconsin in Columbia County. The owner wanted to repair the failing timber walls and eroding slope before adding on to his house. A site visit and soil tests confirmed the need for added slope stability. Working around state shoreline regulations and existing site features, it was decided that an engineered vegetated wall was the best solution.

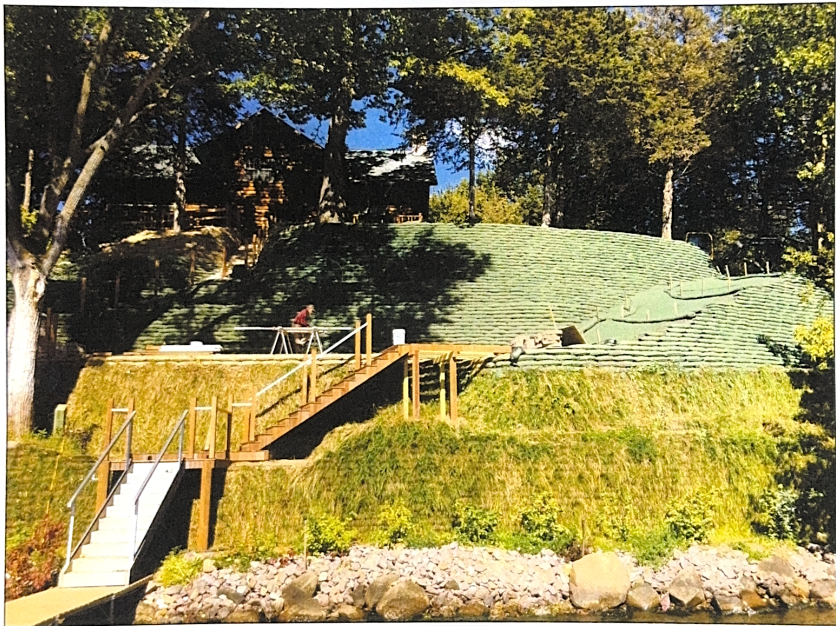
Completed Envirolok progress from the fall of 2015.

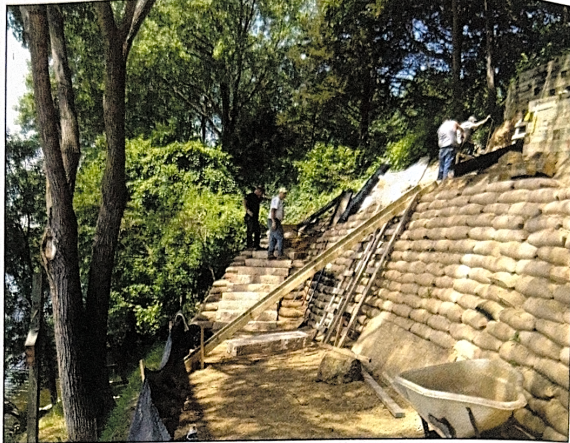
Above: During mid-summer of 2015, installation of steps and removal of timbers were taking place. Below: During early spring of 2014, tube system shown was used to transport native plugs for planting.

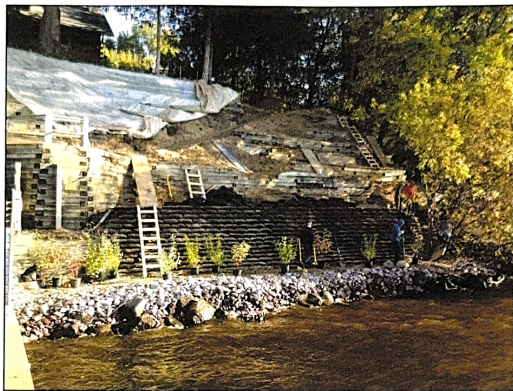
During the fall of 2014, native shrubs were being prepared for planting while soil bag installation was underway.

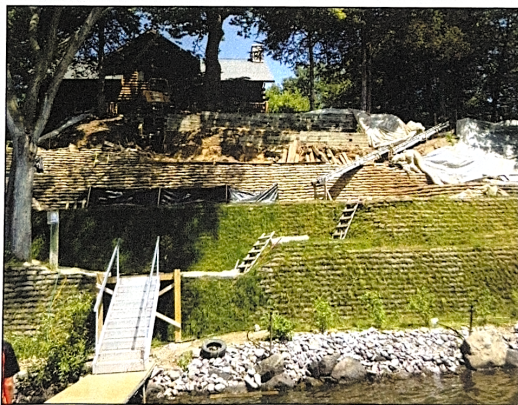
Different stages of the project show the following: vegetated slope on the bottom, constructed wall in the middle, and old existing wall being removed at the top.
